# Home Report

1/2 55 Holmhead Crescent Glasgow G44 4HF

# single survey

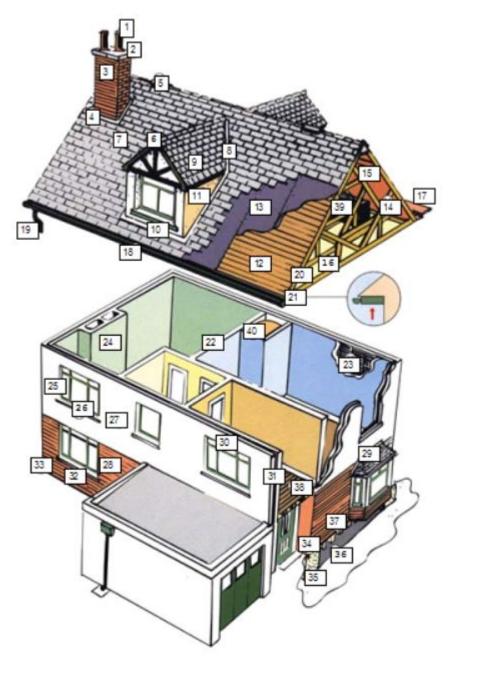
# Sectional Diagram showing elements of a typical house

Reference may be made in this report to some or all of the above component parts of the property. This diagram may assist you in locating and understanding these items.

1 2 3 4 5	Chimney pots Coping stone
1	Chimney head
4	Flashing
5	Ridge ventilation
6	Ridge board
7	Slates/tiles
8	Valley guttering
9	Dormer projection
10	Dormer flashing
11	Dormer cheeks
12	Sarking
13	Roof felt
14	Trusses
15	Collar
16	Insulation
17	Parapet gutter
18	Eaves guttering
19	Rainwater downpipe
20	Verge boards / skews
21	Soffit boards
22	Partition wall
23	Lath / plaster
24	Chimney breast
25	Window pointing
26	Window sills
27	Rendering
28	Brickwork / pointing
29	Bay window
30	Lintels
31	Cavity walls / wall ties
32	Subfloor ventilator
33	Damp proof course
34	Base course
35	Foundations
36	Solum
37	Floor joists
38	Floorboards
39	Water tank
40	Hot water tank
